Geotechnical aspects of the M8.8 2010 Maule, Chile earthquake

Scott M. Olson, PhD, PE

**2012 EERI Annual Meeting &
National Earthquake Conference
April 10-13, 2012
Memphis, Tennessee**

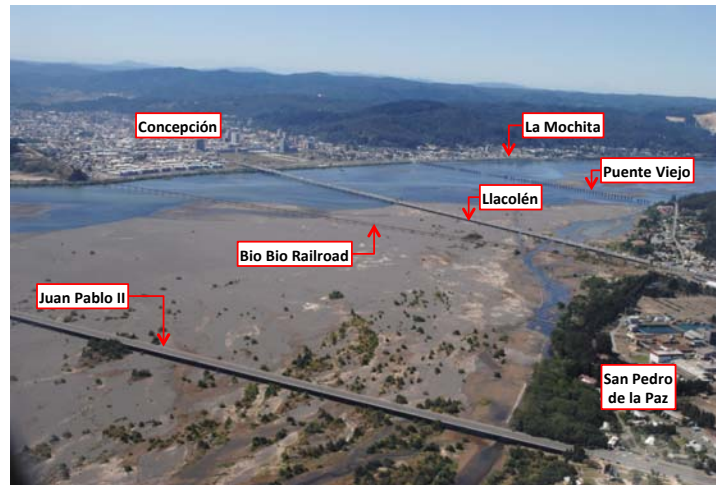
- Many bridges damaged by liquefaction and lateral spreading were located along the Bio-bio River

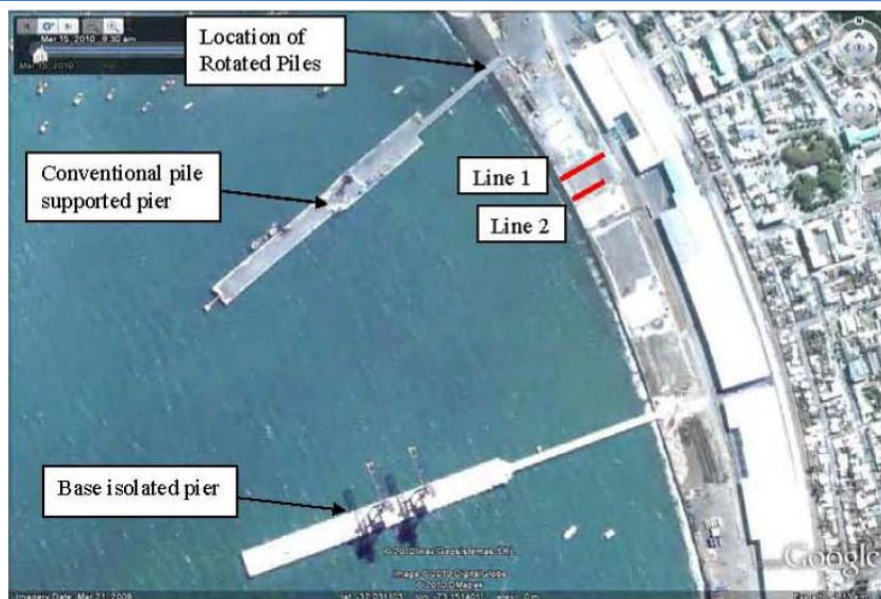
- ◆ Several ports and wharfs damaged by liquefaction and lateral spreading, particularly Port of Coronel and Port of Concepcion
- ◆ Conversely, several ports suffered little to no damage, particularly Port of Valparaiso and Port of San Antonio

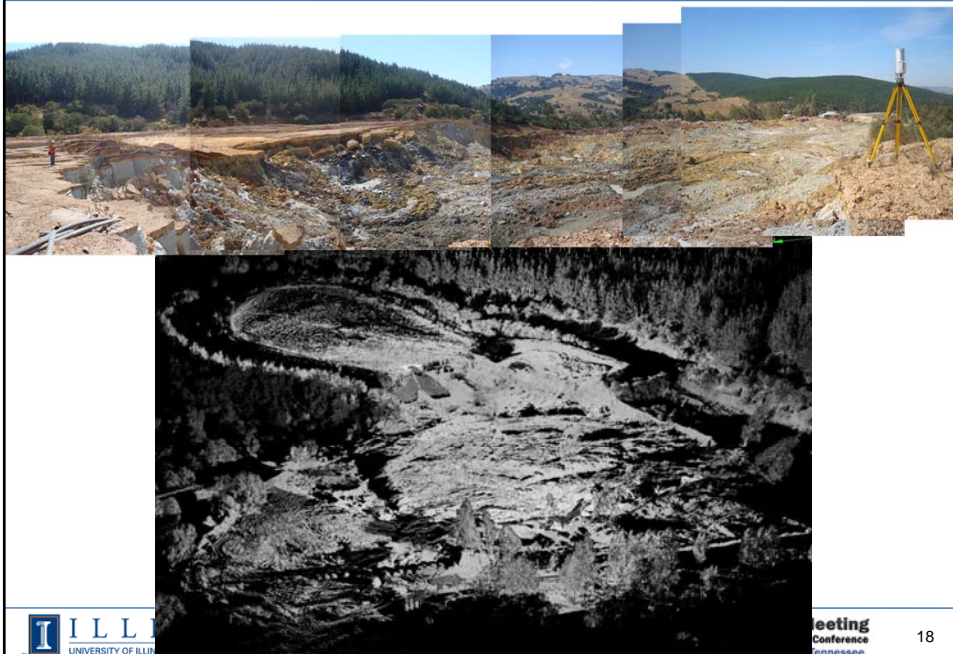
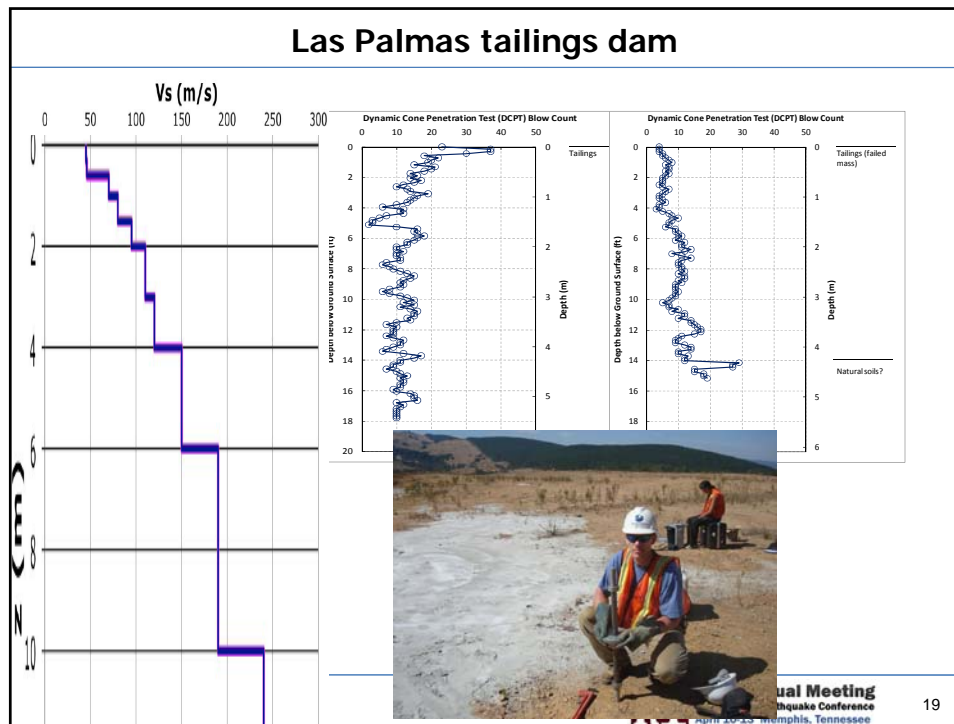
- ◆ Overall, dams and tailings facilities performed well
- ◆ However, Las Palmas tailings dam suffered a massive liquefaction flow failure, killing a family of four (the facility operator)

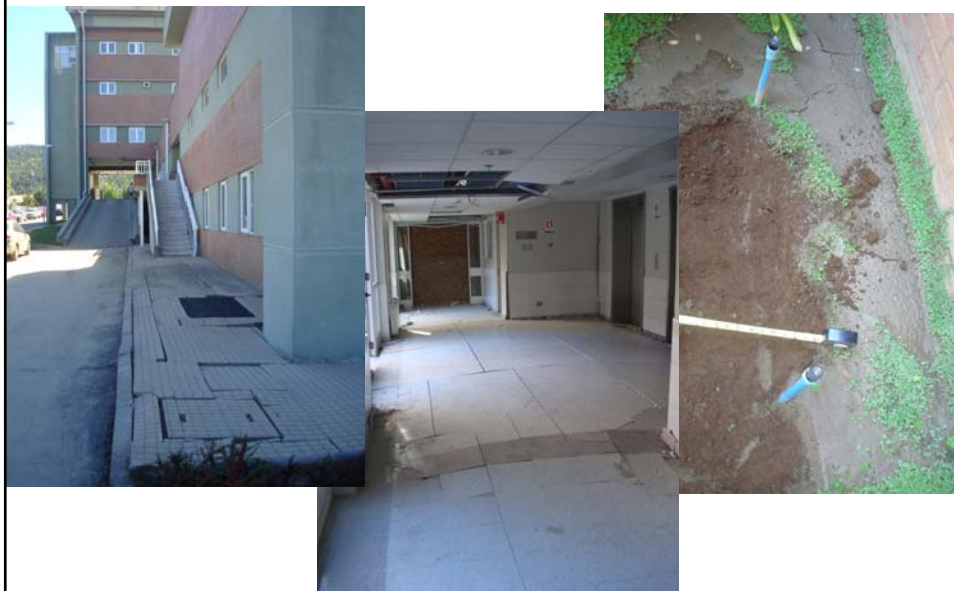
Curanilahue regional hospital

- ◆ Overall, well-engineered buildings performed adequately
- ◆ However, GEER investigated two notable sites where buildings settled and tilted as a result of liquefaction
