**Seismic Performance of Unreinforced Masonry
Structures in Turkey:**

**Van Earthquakes of 23 October and 9 November,
2011**

Polat Gülkan

M. Altuğ Erberik

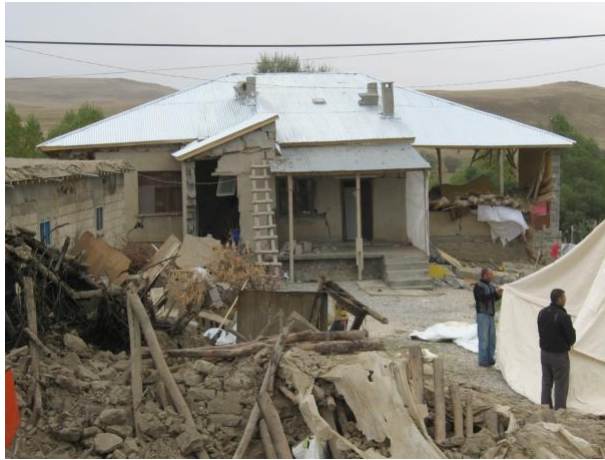
Owner-built, non-engineered and traditional construction

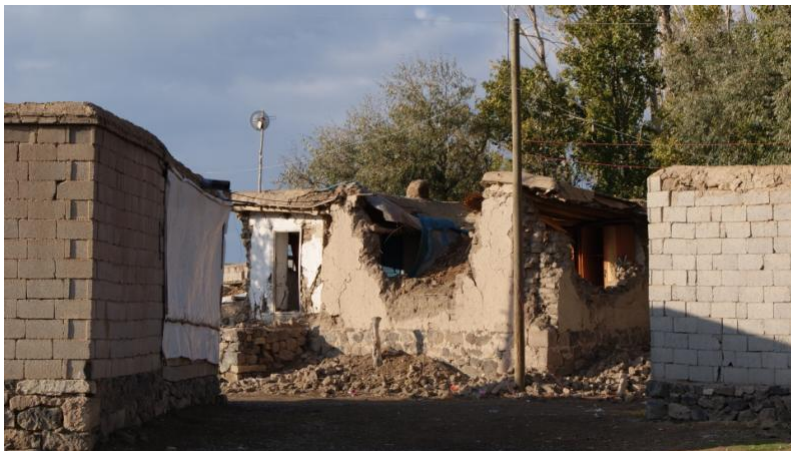
Owner-built, non-engineered and traditional construction

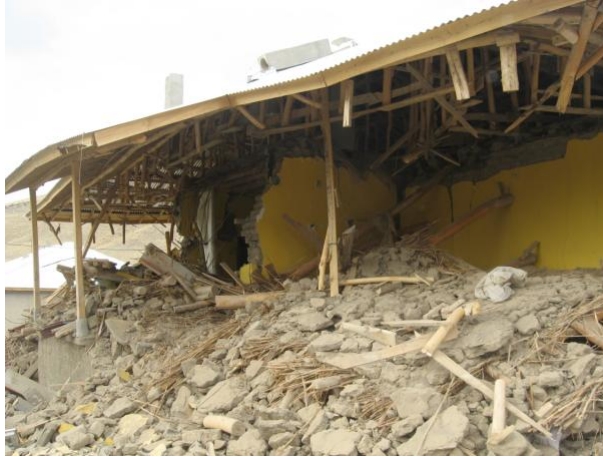
The basic rules of earthquake resistant design are ignored. Articles of the Earthquake Code are based on empirical approach with simple geometrical limitations and stress checks.

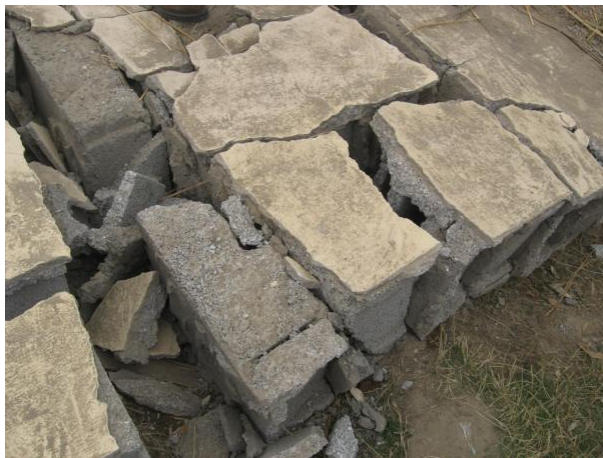
The use of low-strength masonry units (adobe, rubble stone, etc.) due to socio-economic and weather conditions of the region

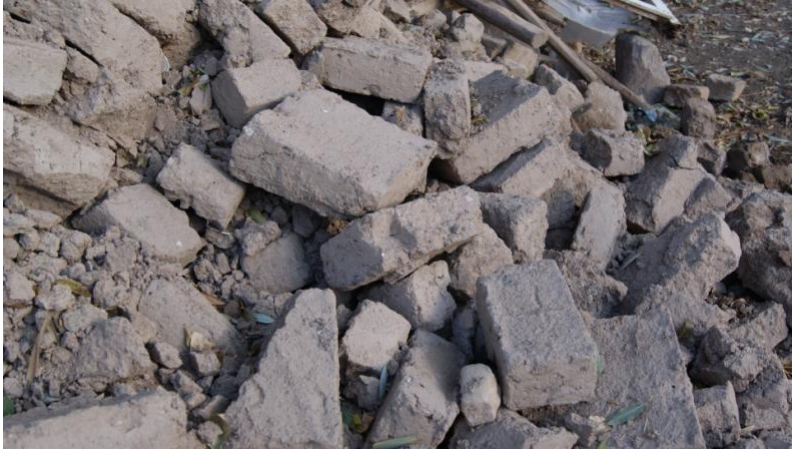
The use of low-strength masonry units (adobe, rubble stone, etc.) due to socio-economic and weather conditions of the region

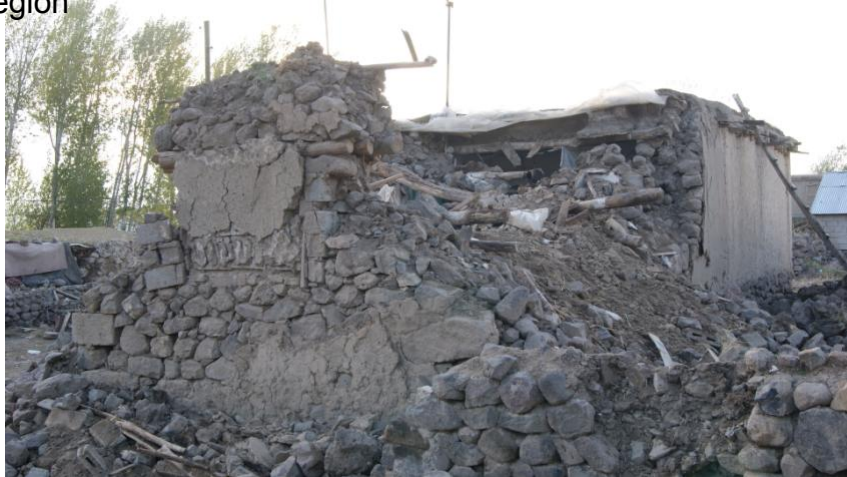
The use of low-strength masonry units (adobe, rubble stone, etc.) due to socio-economic and weather conditions of the region

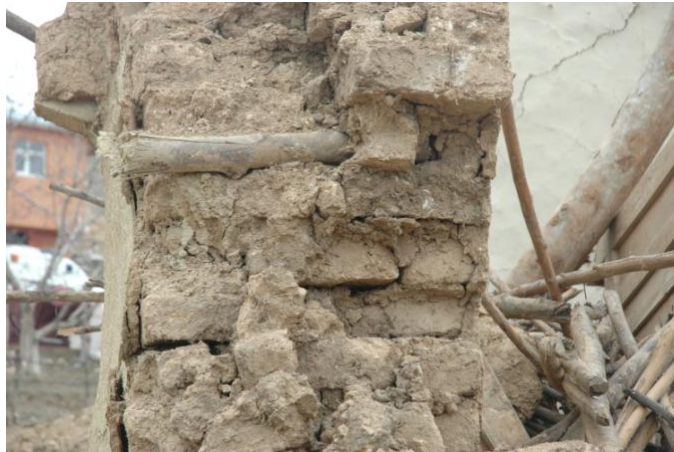
The use of mud mortar (in some cases even no mortar!) with low strength and poor bonding characteristics

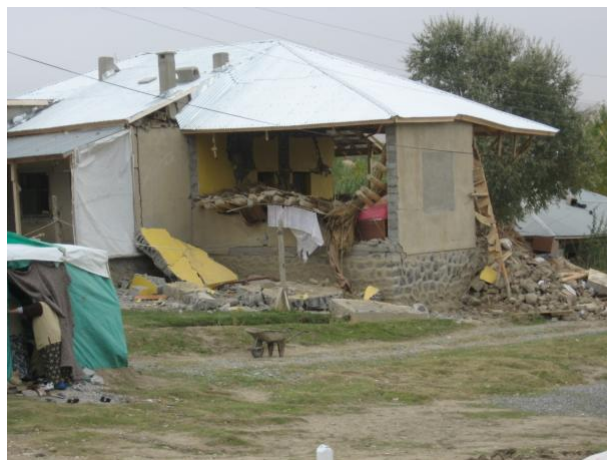
Poor wall-to-wall and wall-to-floor connections, that prevent box-like behavior of the structure.

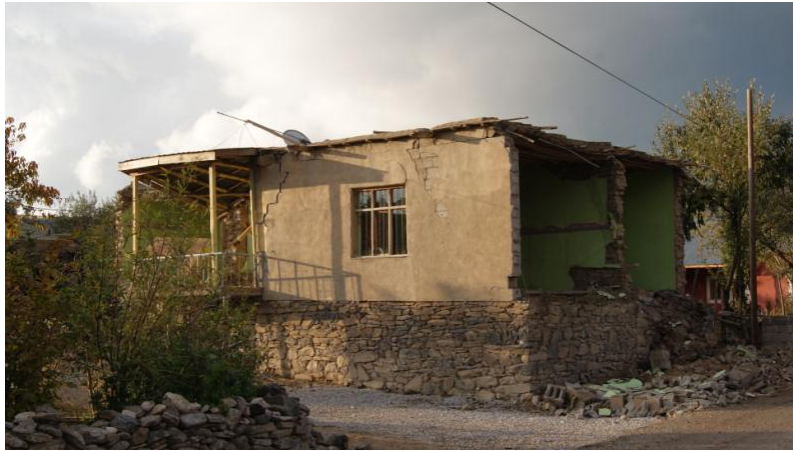
Poor wall-to-wall and wall-to-floor connections, that prevent box-like behavior of the structure.

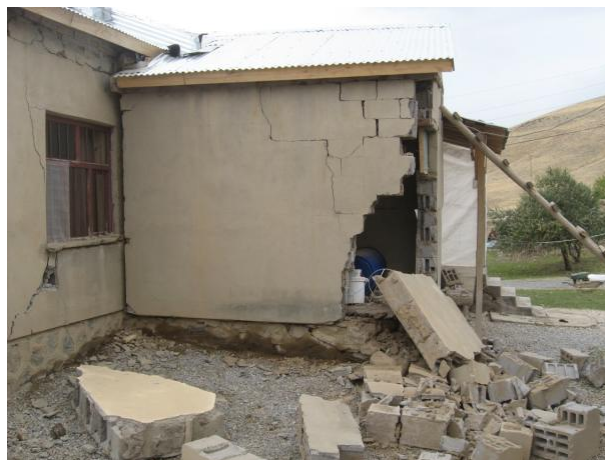
Poor wall-to-wall and wall-to-floor connections, that prevent box-like behavior of the structure.

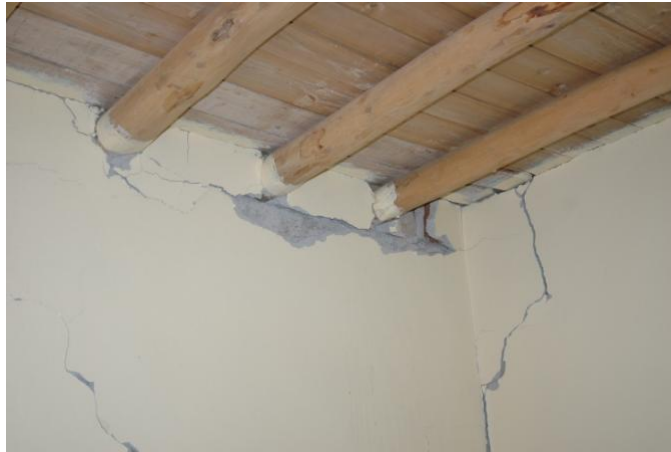
Flexible floor diaphragm, which prevents the transfer and distribution of lateral forces in a uniform manner.

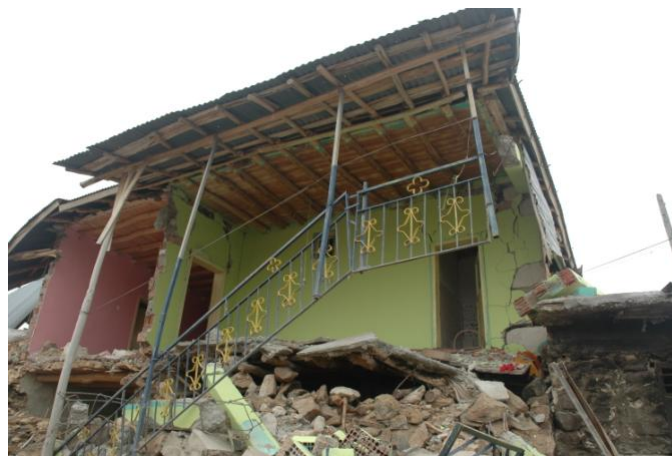
Flexible floor diaphragm, which prevents the transfer and distribution of lateral forces in a uniform manner.

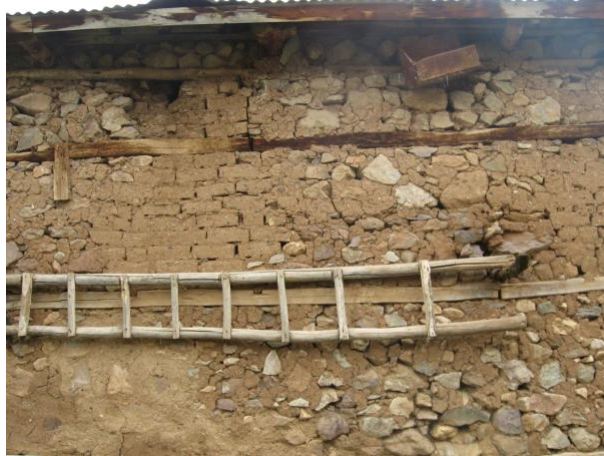
The use of different masonry wall materials in the same building, at the same floor and even at the same wall.

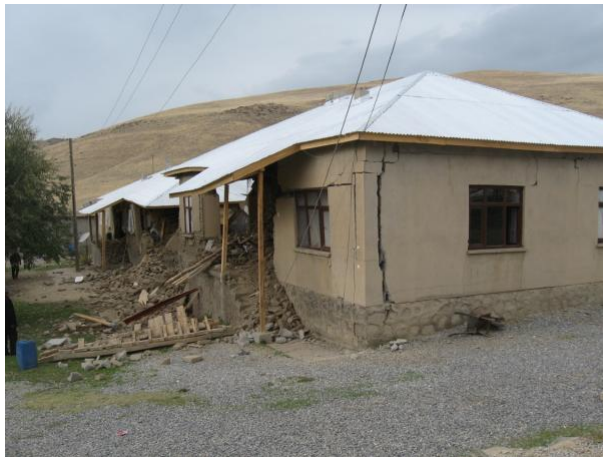
Inadequate amount of load-bearing walls, which causes high shear stresses during ground shaking.

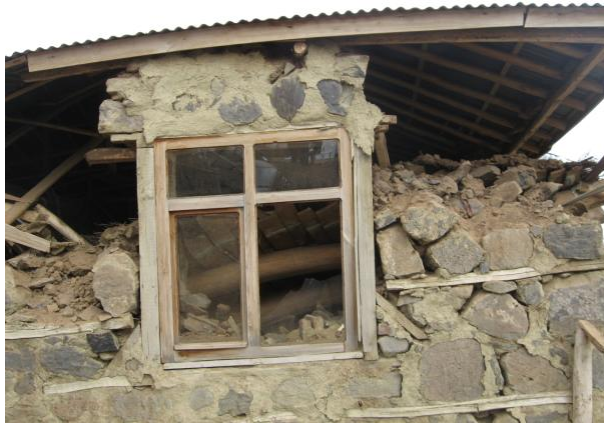
Improper placement of door and window openings in walls, which creates vulnerable and weak zones in the structure.

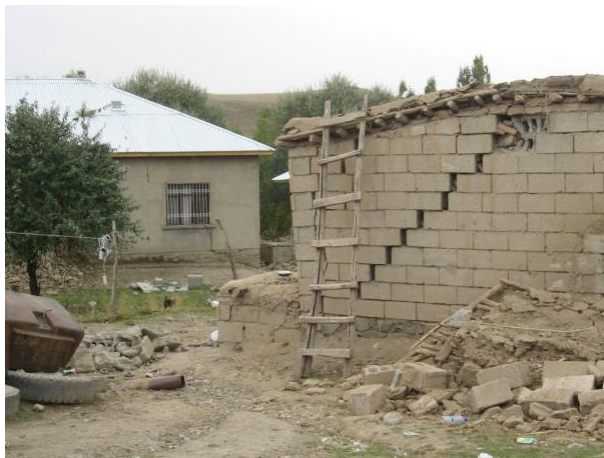
Poor workmanship, which impairs the integrity and capacity of load bearing walls, and in turn whole the structure.

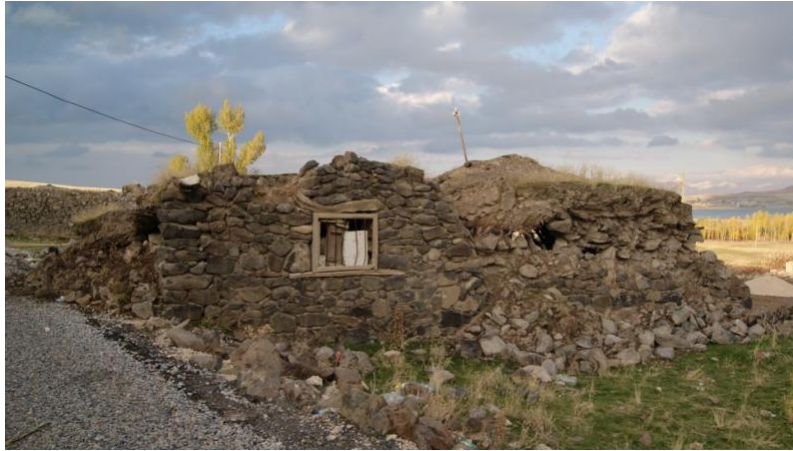
Poor workmanship, which impairs the integrity and capacity of load bearing walls, and in turn whole the structure.

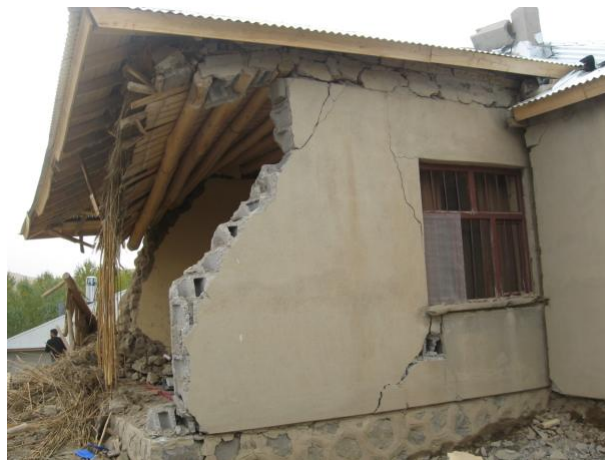
Absence of horizontal bond beams to transfer of earthquake induced loads through the walls to the foundation

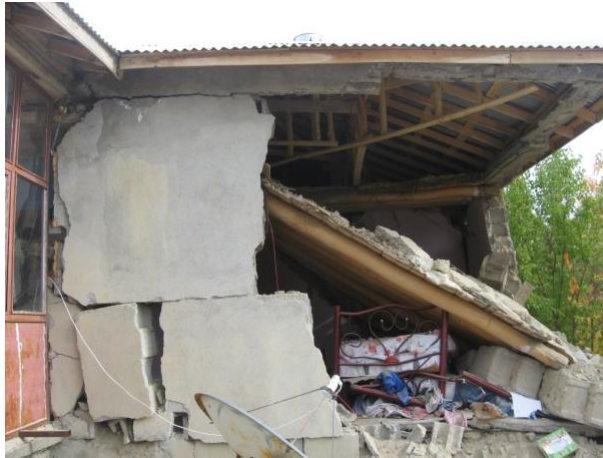
Absence of horizontal bond beams to transfer of earthquake induced loads through the walls to the foundation

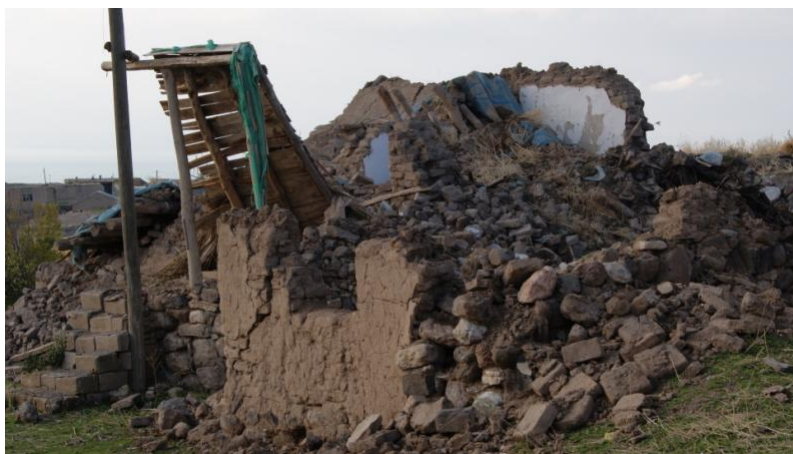
Heavy earthen roofs, which increase the death toll during ground shaking since such type of roofs collapse inwards
