Lessons Learned from the Performance of Highway Bridges in Recent Earthquakes

2012 EERI Annual Meeting & National Earthquake Conference
Memphis, April 2012

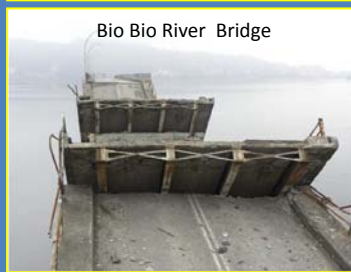
Bio Bio River Bridge

Span unseating due to liquefaction-induced ground movement.

Liquefaction-induced ground movements can unseat spans and damage substructures.	Chile
If site remediation is not feasible, provision of adequate support lengths and/or articulation in superstructure is required to accommodate these movements.	New Zealand

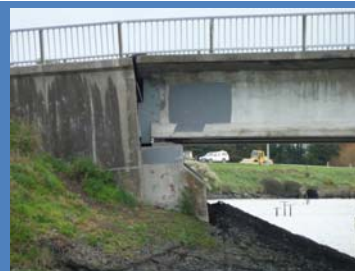
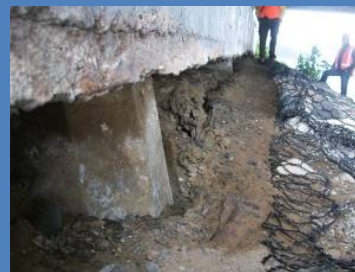
Liquefaction-induced movement of abutment fills damaged piles and caused compressive failures in superstructures of pedestrian bridges

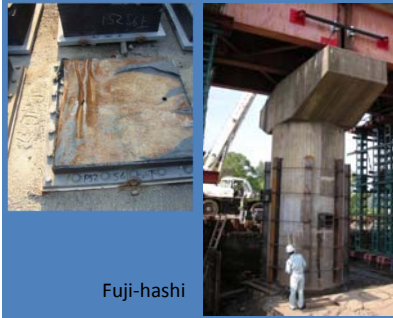
Fuji-hashi

Retrofitted bridges performed very well. Damage to older bridges occurred when retrofitting was not yet undertaken, or was incomplete

Capacity design principles and inelastic analysis are effective	Japan
Retrofit programs are effective at protecting older structures. Owner agencies need encouragement/incentives to complete retrofit programs. Validates FHWA/Caltrans 30-year effort in US to retrofit bridge inventory	Japan (New Zealand)
Check the load path for surprises... and the back-up load path	Chile New Zealand Japan
