Talk Outline

Impact to Critical Healthcare Infrastructure

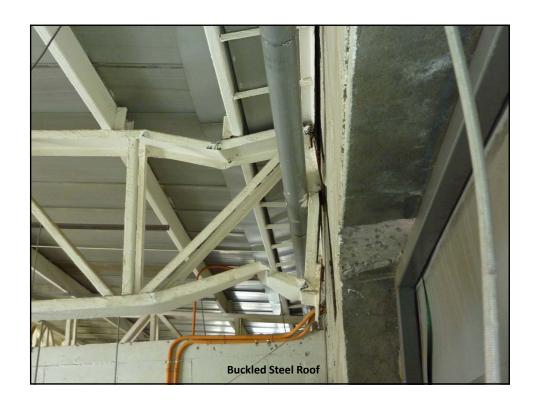
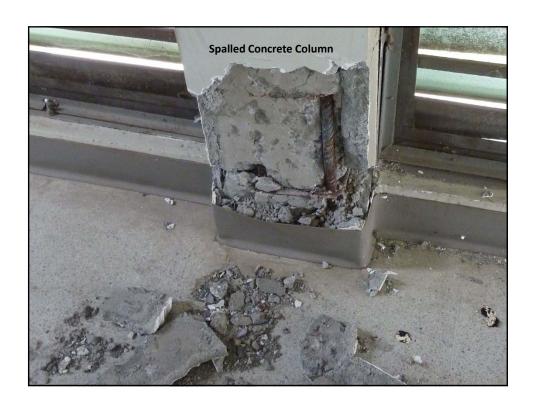
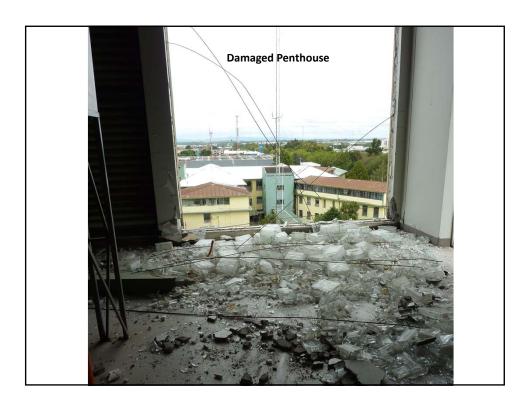
Structural Damage

- Chile: 1 of the 7 facilities had moderate structural damage; this
 hospital braced by concrete frames with shear walls suffered
 buckled steel roof trusses and severe racking of its penthouse due
 to torsion and steel roof trusses buckled; spalled concrete of
 columns, cracking in shear walls, and collapsed in-fill walls.
- Mexico: no severe structural damage was observed.
- New Zealand: one of the hospitals suffered permanent deformation shutting down its maternity ward and part of its ICU; a lot of damage to separation joints.

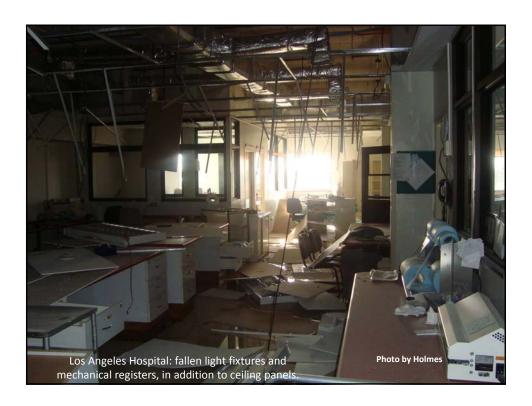
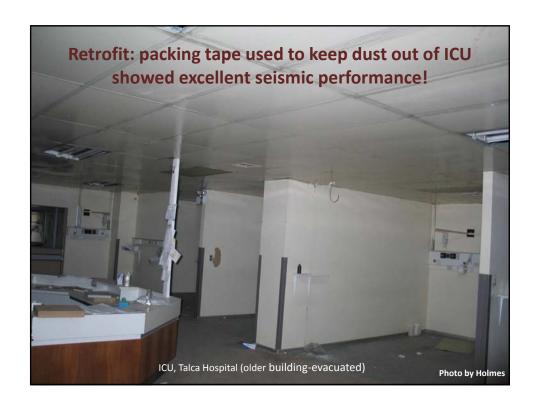
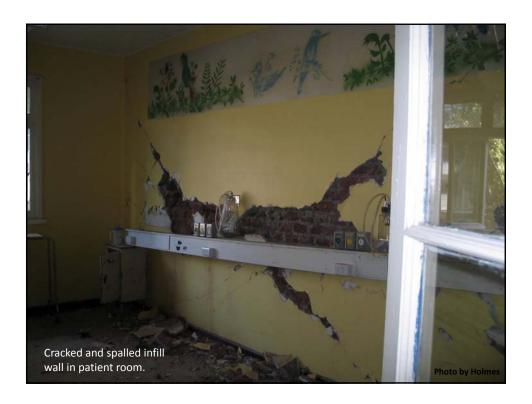
Nonstructural Damage

- Chile: broken pipes, collapsed ceilings, heavy partition wall damage, oxygen tanks suffered tensile yield failure of threaded fasteners and punching shear failure of the tank leg, widespread elevator damage, collapsed furniture (including medical record storage); mechanical and medical equipment damage resulted in loss of hot water affecting kitchen, laundry, and sterilization services, which forced hospitals to sterilize off site, and disrupted diagnostic services.

- Mexico: broken pipes, collapsed ceilings, heavy partition wall damage, oxygen tanks suffered tensile yield failure of threaded fasteners and punching shear failure of the tank leg, widespread elevator damage, collapsed furniture (including medical record storage).

- **New Zealand**: one of the hospitals suffered permanent deformation shutting down its maternity ward and part of its ICU; a lot of damage to separation joints.

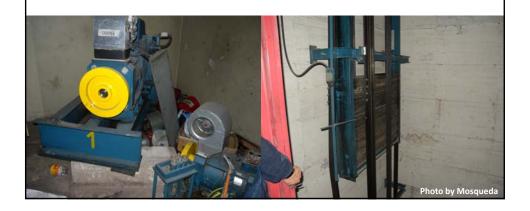
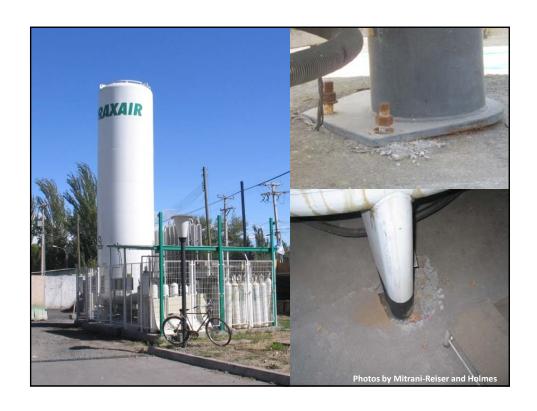
- Elevators suffered significant failures in Chile, most due to derailed counterweights; patients were carried down stairs or ramps.
- In Mexico and NZ where elevators continued to function, staff were fearful of riding in them and thus relied on dark stairwells instead.

Still working on straightening out Talcahuano medical records after 3 weeks
