**2012 EERI  
Annual Meeting**

## Performance of Masonry Structures in Christchurch, New Zealand during the 2010/2011 Earthquakes

**Arturo E. Schultz**  
*Department of Civil Engineering*

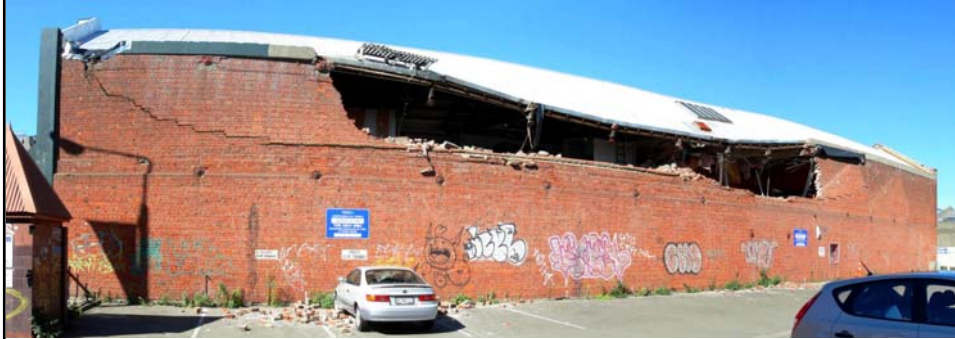
## Out-of-plane failures

Diaphragm flexibility responsible for failure  
Note the anchorages into roof diaphragm

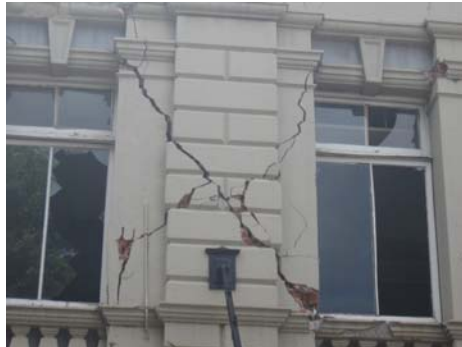
## Pier failures

Diagonal pier failure reasonably well understood  
Spandrel failure over arched windows requires more attention

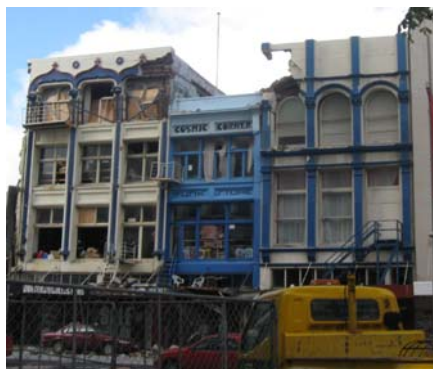
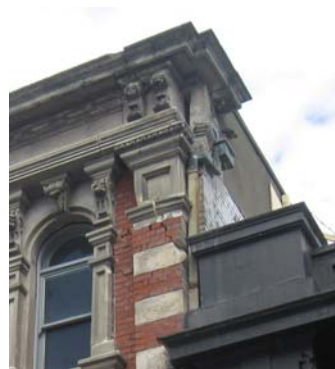
## Pounding damage

Widespread examples of pounding damage

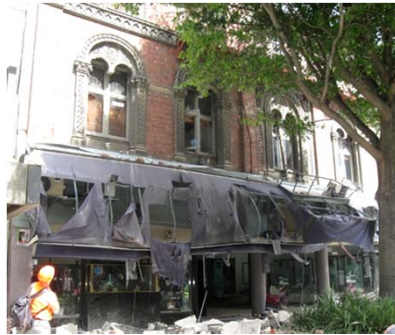
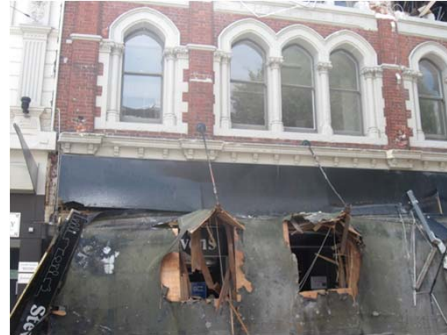
## Awnings/canopies and anchorage failures

Failures observed at both ends of braces

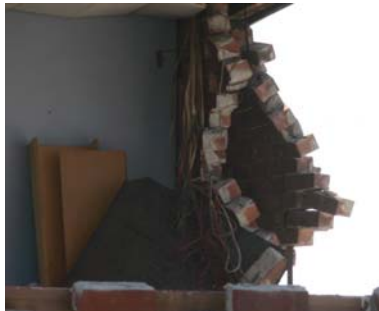
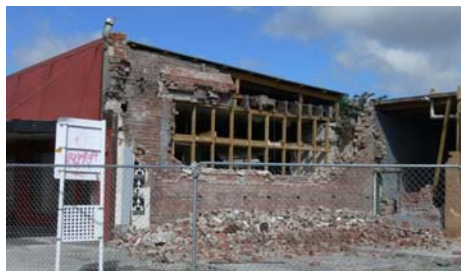
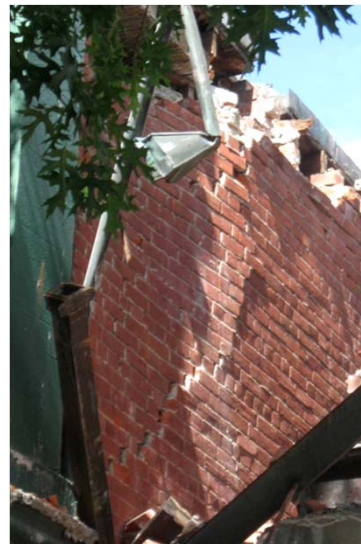
Cavity construction often lacked  
header bricks to tie the wythes

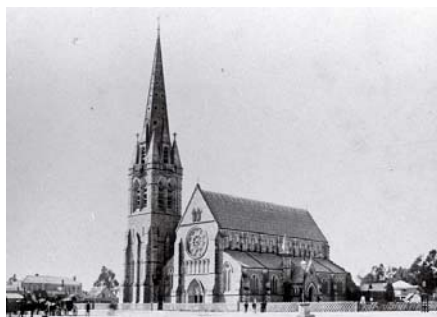
## The Christchurch Cathedral

The Cathedral was designed by the Englishman G.G. Scott and work began on it in 1863. The tower and spire, paid for by the Rhodes family, are complete in the photograph but were damaged multiple times by earthquakes in 1881, 1888 and 1901.

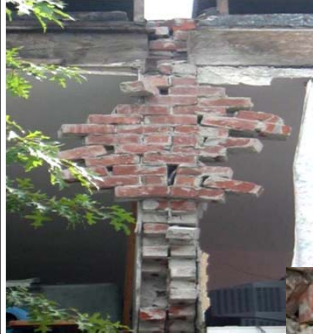
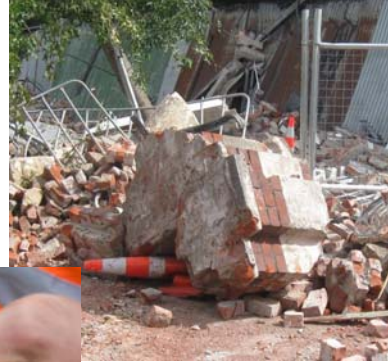
## Poor quality of mortar

- $\tau = c_0 + \mu \cdot \sigma_v$
- $\sigma_v$  is low
- Vertical acc's high

Many samples tested  
Compression strengths  
were 1.0 – 1.5 MPa  
(150 – 200 psi)

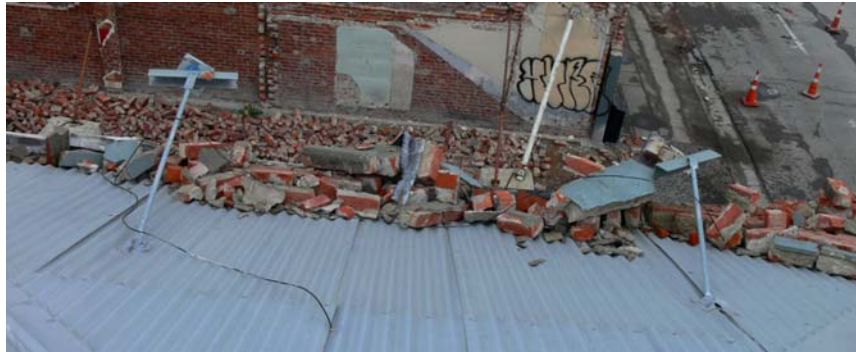
## Unsuccessful Parapet Strengthening

Wall has detached from struts

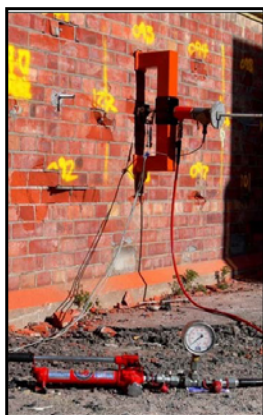
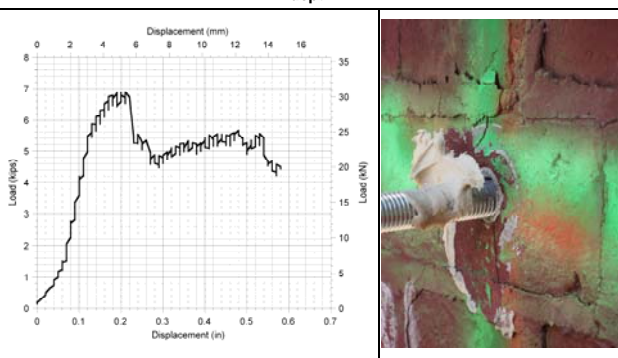
## Field Study of Adhesive Anchor Performance

Anchor Test 054 / Building A / Adhesive 1 / Sleeved / Straight / 16mm  $\phi$  / 400mm depth
