Response of the Fukushima Dai-ichi Nuclear Plant to the March 11, 2011 Earthquake in Japan

Dr. George Flanagan
Oak Ridge National Laboratory
Presented to the EERI/NEC
Meeting
April 12, 2012

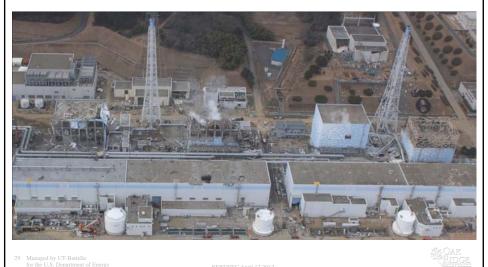
Unit 1

Result Was An Explosion in Units 1 and 3 Destroying Parts of the Reactor Buildings

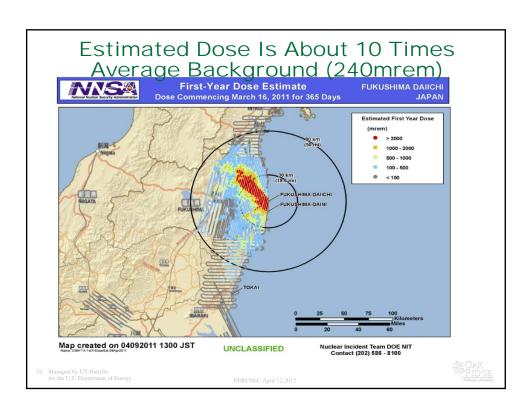
Most of the Time Following the Accident the Wind was Blowing Towards the Sea, However, There Were Times When the Winds Blew Towards the Northwest

- Resulted in a Plume Carrying Radiation to Drift Inland
 - Mandatory Evacuation Ordered for 20 km around the plant
 - Area between 20-30km asked to shelter in place and later advised to evacuate
 - Some areas in path of plume affected beyond 30km
 - Over 70,000 inhabitants affected by evacuation
