Geotechnical Lessons from Recent Earthquakes

An Overview of the Geotechnical Aspects of the 2010-2011 Canterbury, New Zealand Earthquake Sequence

Russell A. Green

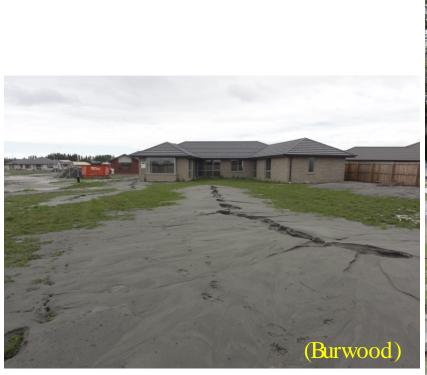
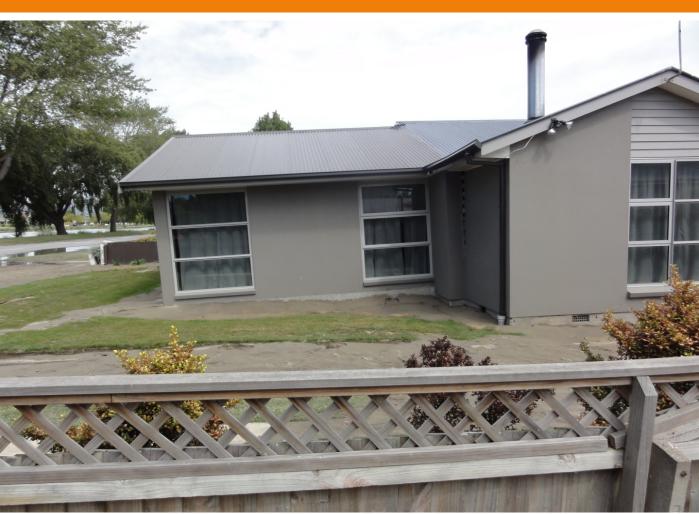
Severe Liquefaction in Eastern Suburbs

- Large settlement of residential houses (total and differential)

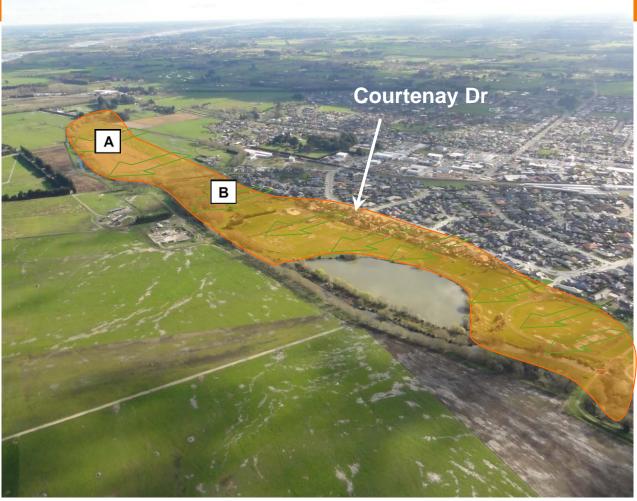
Lateral Spreading

• Low gradients at both locations (~3°)

(Misko Cubrinovski: South Kaiapoi)

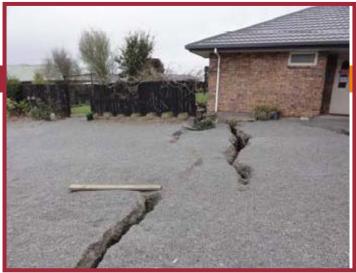
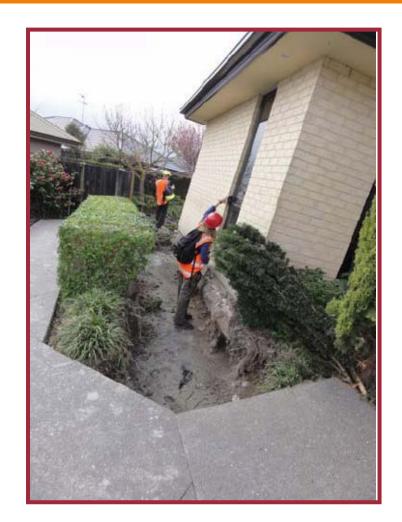
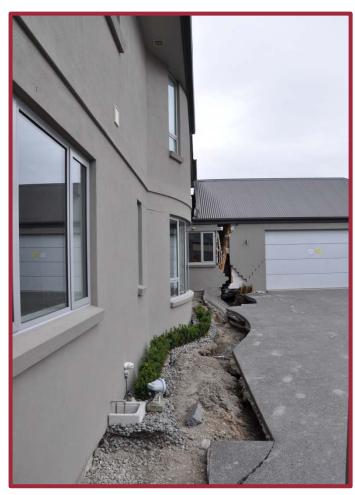
Lateral Spreading

~ 1.5 m wide cracks

(Misko Cubrinovski: South Kaiapoi)
