Life-Safety Risks to Schools from Nonstructural Earthquake Damage

2012 EERI ANNUAL MEETING AND
NATIONAL EARTHQUAKE CONFERENCE

Presented by
Michael J. Griffin, P.E.
Principal
CCS Group, Inc.

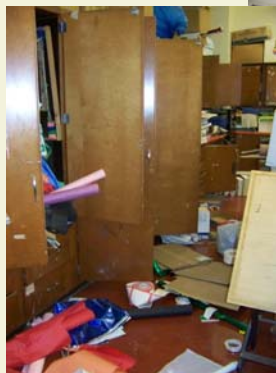
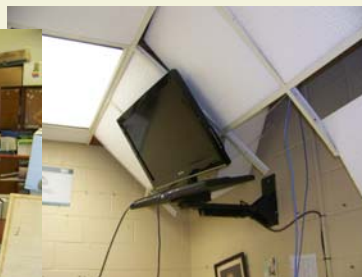
Interior contents and ceiling damage

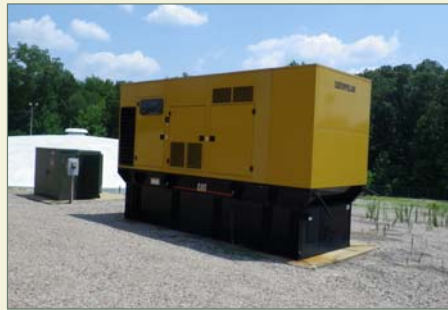
Diesel emergency generator (unanchored)

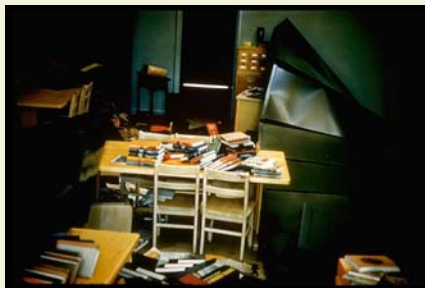
*Lakeside School Library
Kern County Earthquake - 1952
Photo Credit - M. Knox*

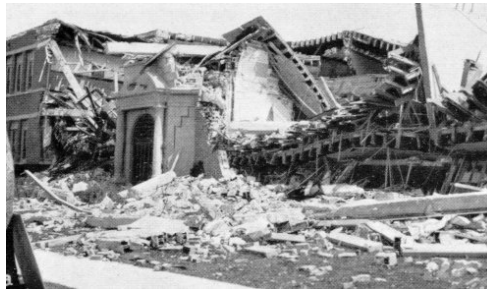
URM buildings heavily damaged

Jefferson Junior H.S. Photo Credit – EERC

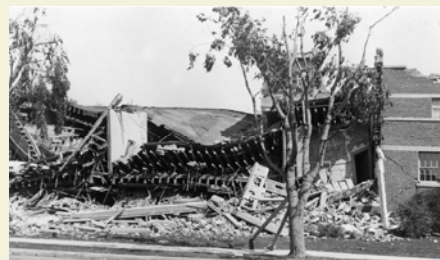
Jefferson Junior H.S. Photo Credit – TJ Maher
