***EXPECTED PERFORMANCE  
OF URM'S  
IN MEMPHIS, TN***

2012 EERI Annual Meeting/  
National Earthquake Conference

*Richard W. Howe, PE*  
Structural/Risk Consultant  
R.W. Howe and Associates, PLC  
Memphis, Tennessee

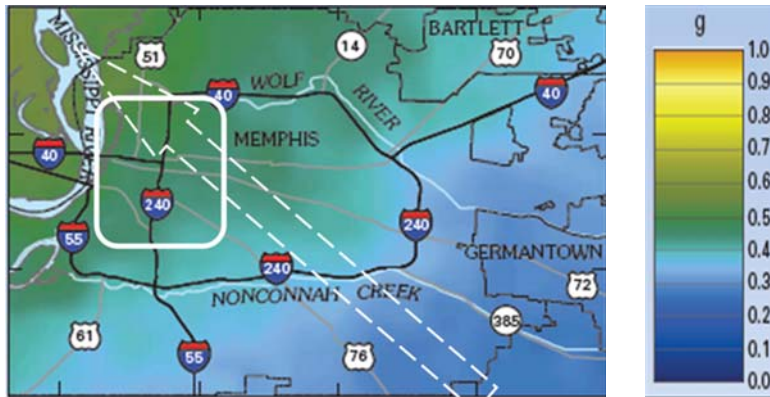
- URM's concentrated in older areas of Memphis (Downtown & Midtown)

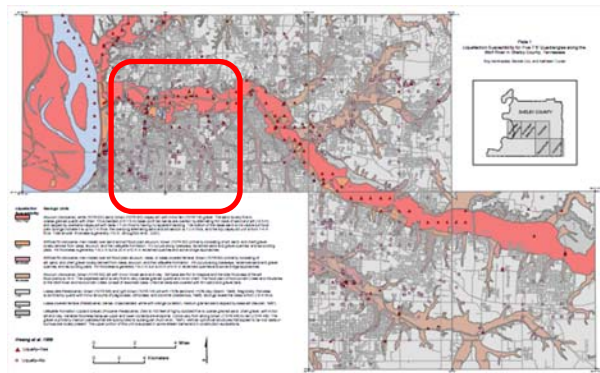
- URM's typically not impacted by liquefaction hazard

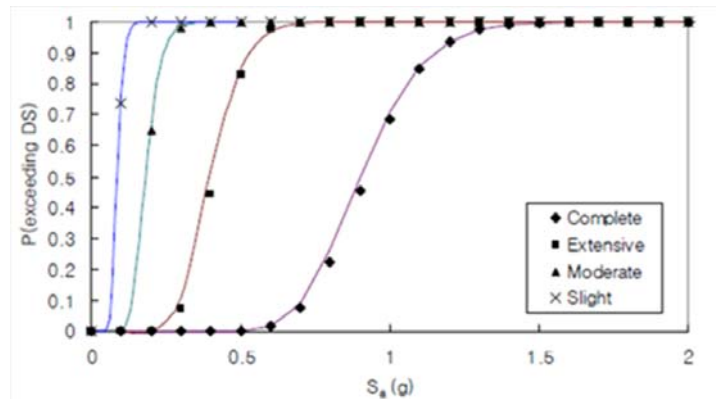
Analytical Fragility Assessment of Low-Rise URM Buildings (Park Goodno et al) 2008

Figure 6: Fitted Fragility Curves

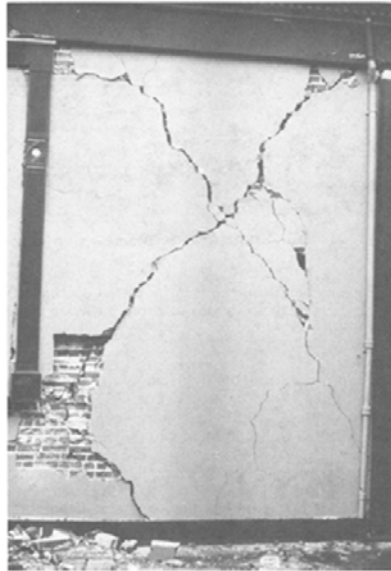
FIG. 2. In-Plane Shear Failure of URM Masonry Wall (Santa Cruz, Loma Prieta Earthquake)

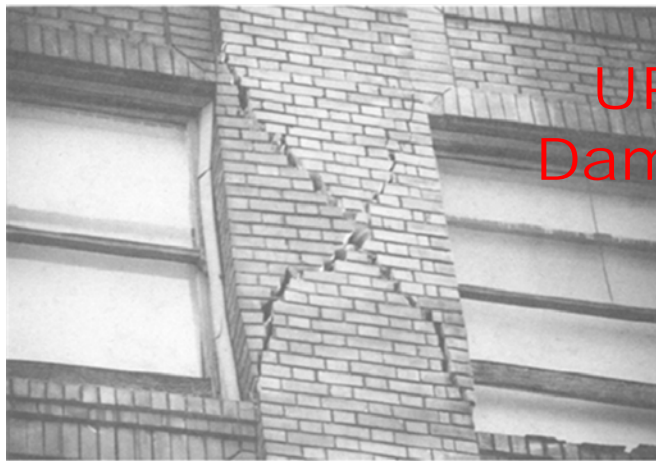
FIG. 4. In-Plane Shear Failure of URM Pier (Oakland, Loma Prieta Earthquake)

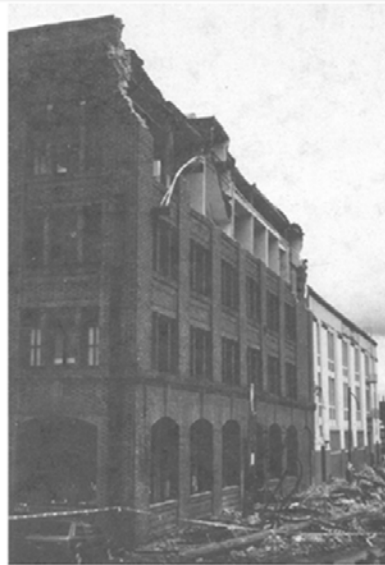
FIG. 6. Out-of-Plane Failure of URM Top-Story Wall (San Francisco, Loma Prieta Earthquake)

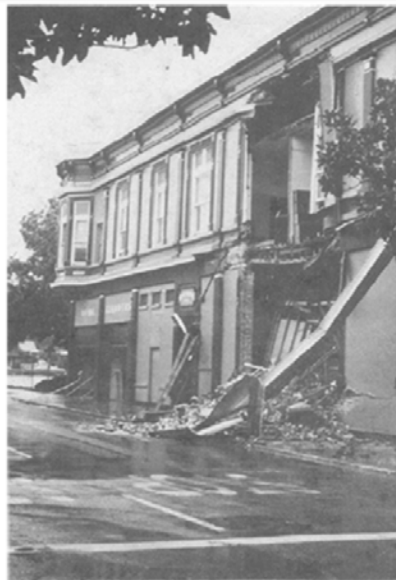
FIG. 7. Out-of-Plane Failure of URM Wall at Center of Building due to Excessive Diaphragm Flexibility (Santa Cruz, Loma Prieta Earthquake)

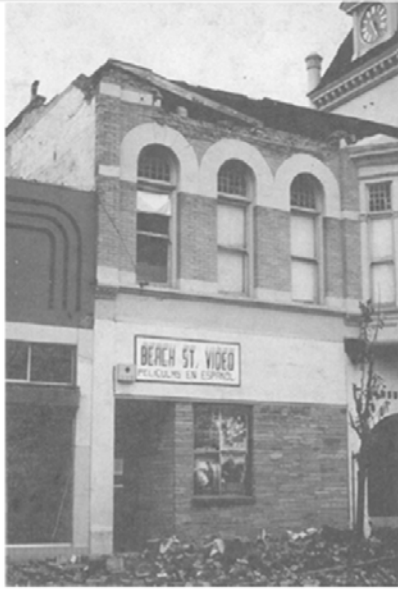
FIG. 8. Parapet Failure of 100 Front Street Building (Watsonville, Loma Prieta Earthquake)

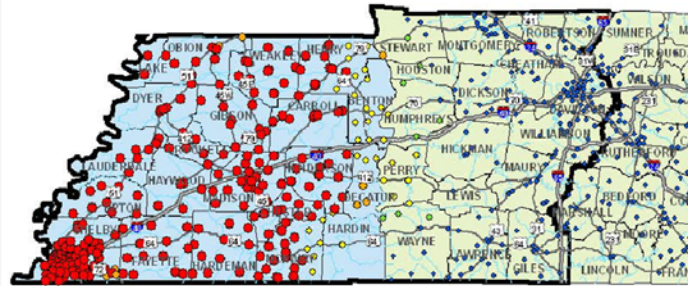
Fire Station Damage - New Madrid Seismic Zone: M7.7 Event
