April 12, 2012

AFTERSHOCK COLLAPSE FRAGILITY FOR MAINSHOCK DAMAGED REINFORCED CONCRETE BUILDINGS

Abbie Liel, Ph.D., P.E.
University of Colorado, Boulder

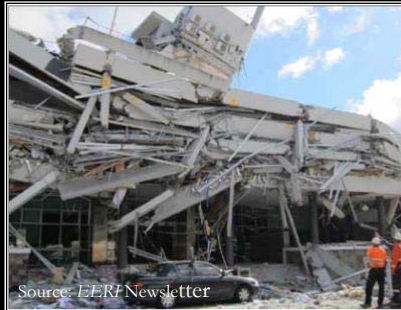
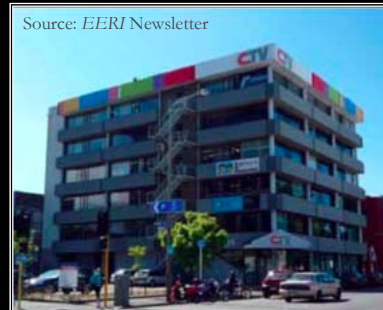
BUILDING STUDIED

- 4-Story **nonductile** reinforced concrete frame building
- Representative of typical nonductile concrete construction in New Zealand

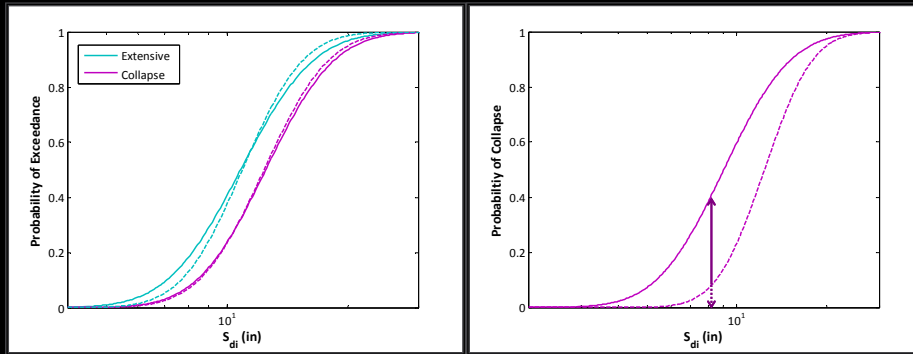
EFFECT OF MAINSHOCK DAMAGE

Building Moderately Damaged in Mainshock

Building Extensively Damaged in Mainshock
