**Seismic Performance of Unreinforced Masonry
Structures in Turkey:**

**Van Earthquakes of 23 October and 9 November,
2011**

Polat Gülkan

M. Altuğ Erberik

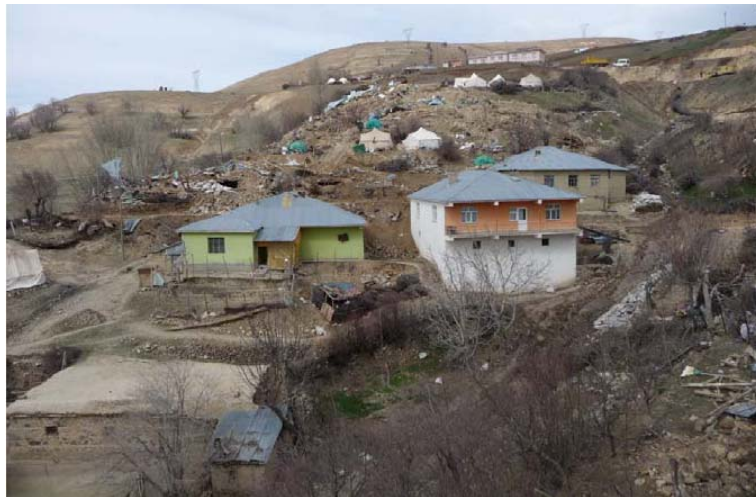
A Recent Moderate Earthquake (Elazığ, 2010)

- An earthquake with $M_w = 6.1$ occurred in the Elazığ region of Eastern Turkey on March 08, 2010
- 42 people lost their lives and 137 were injured during the event.
- The earthquake caused major structural damage in few villages where all the fatalities were reported after the earthquake.
- Most of the severely damaged or collapsed structures are rural type stone or adobe masonry buildings.
