Utility Earthquake Mitigation

Considerations
Requirements
Actions

Donald W. Shaw P.E.
National Earthquake Conference
April 13, 2012

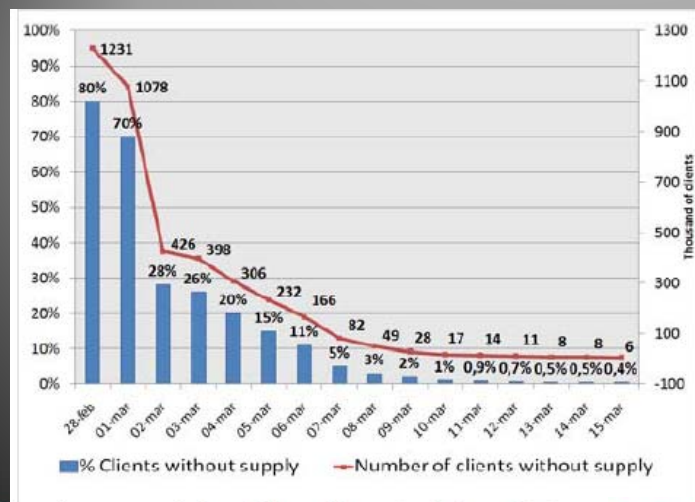
Electricity Supply Impacts

Distribution
